Teradyne, Inc

Release Notes: Spectrum Release 5.1

November 2009

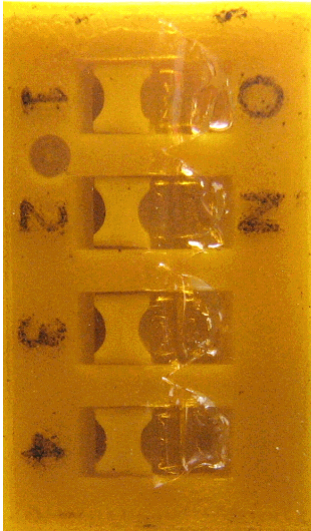
OFF Position

- If there is a single FrameScan Mux board mounted in the fixture, all switches must be in the Off position as marked on the switch. This switch position is towards the numbers labeled on the switch.

If you are unsure, use an OHM meter to verify the Off setting.

- If more than one FrameScan Mux board mounted in the fixture, use SW1 to specify its address.
